Wind Turbine Blade Inspection Report

Inspection Date: Jun 05, 2017

Client:
Site: Shroyer Wind Farm
Turbine: MW2 WTG-27

Turbine MW2 WTG-27

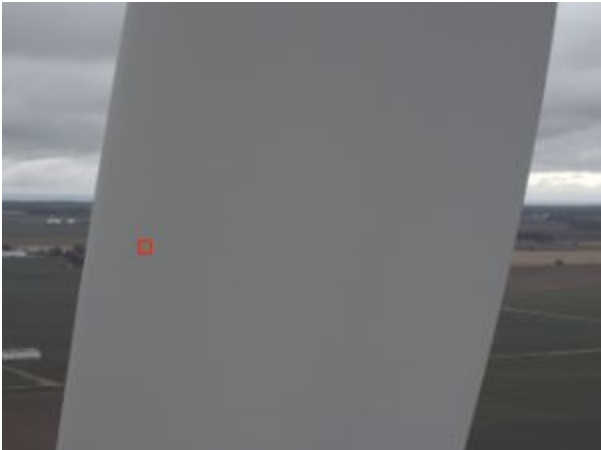
<p>Original: DJI_0019.DNG (Larger Version)</p>	1	<table border="1"> <tr> <td>Chip</td> <td>629x,1079y</td> <td>Mosaic 3014x,1061y</td> </tr> </table>	Chip	629x,1079y	Mosaic 3014x,1061y
Chip	629x,1079y	Mosaic 3014x,1061y

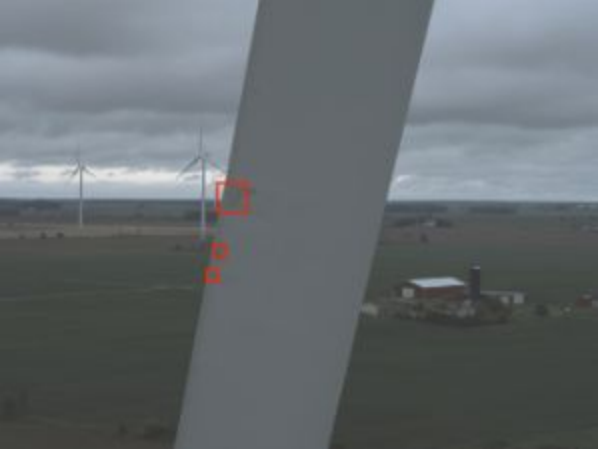
Original: DJI_0044.DNG (Larger Version)

<div style="border: 1px solid black; background-color: yellow; padding: 5px; width: 30px; margin: 0 auto;">2</div>	<table border="1" style="width: 100%; border-collapse: collapse;"> <tr> <td style="background-color: #e6f2ff;">Chip</td> <td style="background-color: #e6f2ff;">1023x,875y</td> <td style="background-color: #e6f2ff;">Mosaic 9359x,1244y</td> </tr> <tr> <td style="background-color: #e6f2ff;">Chip</td> <td style="background-color: #e6f2ff;">968x,1108y</td> <td style="background-color: #e6f2ff;">Mosaic 9451x,1252y</td> </tr> <tr> <td style="background-color: #e6f2ff;">Chip</td> <td style="background-color: #e6f2ff;">936x,1219y</td> <td style="background-color: #e6f2ff;">Mosaic 9506x,1260y</td> </tr> </table>	Chip	1023x,875y	Mosaic 9359x,1244y	Chip	968x,1108y	Mosaic 9451x,1252y	Chip	936x,1219y	Mosaic 9506x,1260y

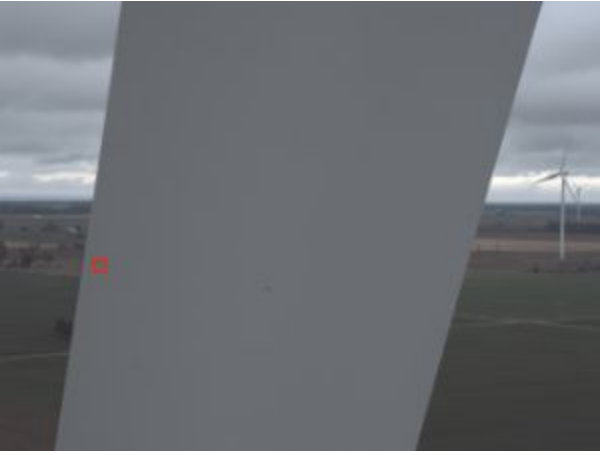
1	<table border="1"> <tr> <td>Stain</td> <td>437x,1165y</td> <td>Mosaic 4660x,1146y</td> </tr> </table>	Stain	437x,1165y	Mosaic 4660x,1146y
Stain	437x,1165y	Mosaic 4660x,1146y			
Original: DJI_0026.DNG (Larger Version)

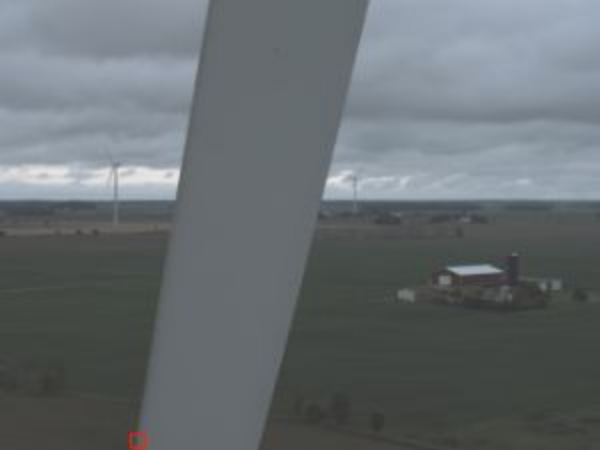
1	<table border="1"> <tr> <td>GCE</td> <td>607x,1941y</td> <td>Mosaic 11874x,1335 y</td> </tr> </table>	GCE	607x,1941y	Mosaic 11874x,1335 y
GCE	607x,1941y	Mosaic 11874x,1335 y			
Original: DJI_0052.DNG (Larger Version)

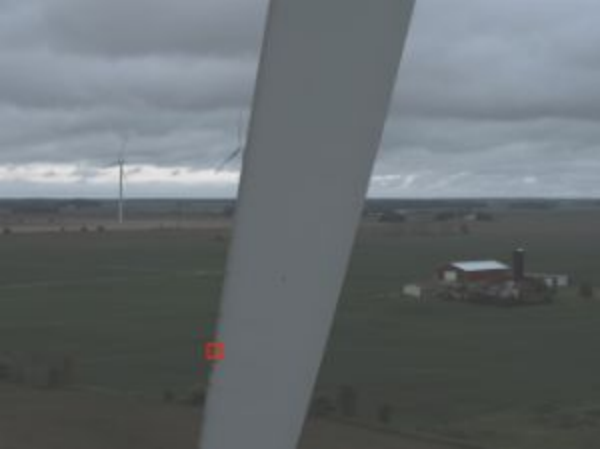
1	<table border="1"> <tr> <td>GCE</td> <td>946x,1549y</td> <td>Mosaic 11950x,1318 y</td> </tr> </table>	GCE	946x,1549y	Mosaic 11950x,1318 y
GCE	946x,1549y	Mosaic 11950x,1318 y			
Original: DJI_0053.DNG (Larger Version)

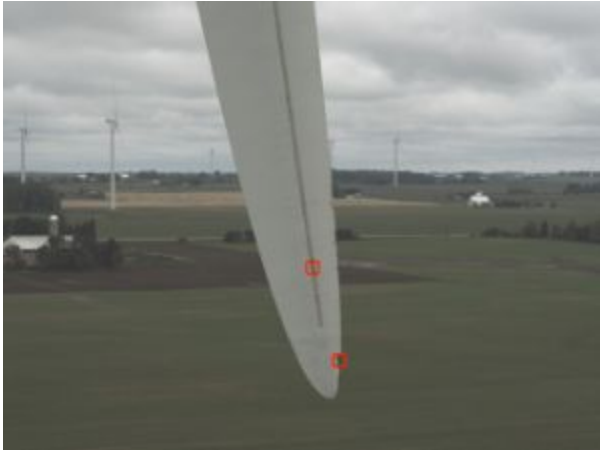
Original: DJI_0157.DNG (Larger Version)

MissingVortex Panel	1363x,1173y	Mosaic 12318x,308y
GCE	1480x,1582y	Mosaic 12472x,284y

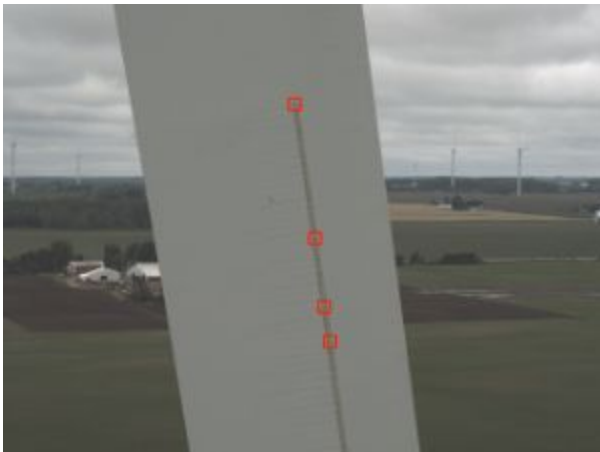
Original: DJI_0143.DNG (Larger Version)

VortexDamage	1284x,442y	Mosaic 8512x,346y
VortexDamage	1373x,1031y	Mosaic 8766x,338y
VortexDamage	1414x,1333y	Mosaic 8958x,331y
VortexDamage	1439x,1485y	Mosaic 9019x,346y

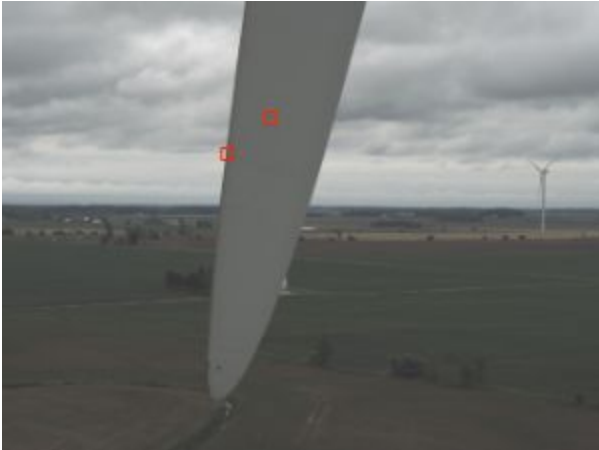
Original: DJI_0052.DNG (Larger Version)

Anomaly	1183x,515y	Mosaic 1183x,515y
GCE	992x,673y	Mosaic 12101x,1359 y

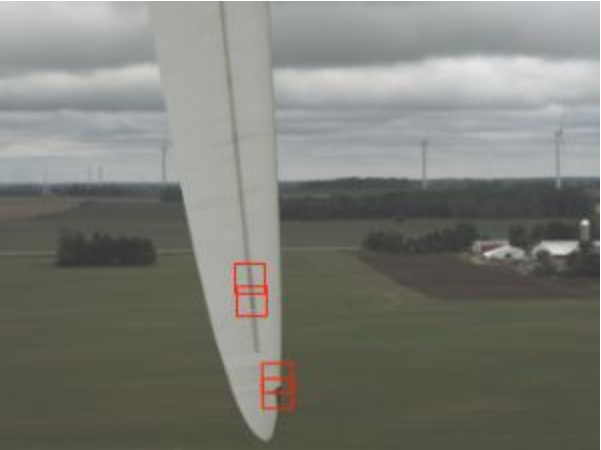
Original: DJI_0064.DNG (Larger Version)

2	MissingVortex Panel	1100x,1222y Mosaic 12399x,136y
		MissingVortex Panel	1108x,1322y Mosaic 12359x,128y
		GCE	1220x,1659y Mosaic 12391x,108y
		GCE	1222x,1728y Mosaic 12435x,116y

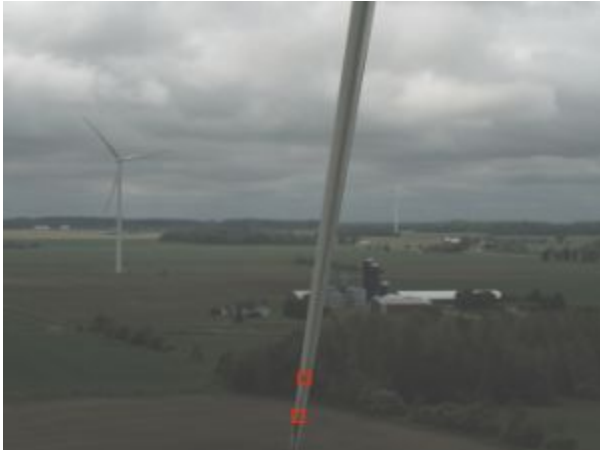
Original: DJI_0116.DNG (Larger Version)

GCE	1300x,1826y	Mosaic 12166x,299y
GCE	1327x,1661y	Mosaic 12082x,299y

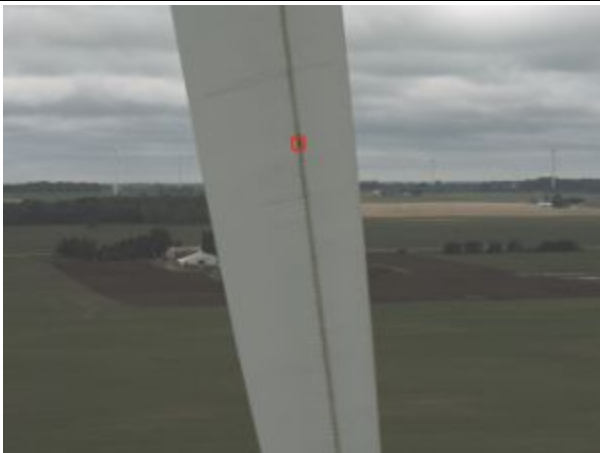
Original: DJI_0179.DNG (Larger Version)

MissingVortex Panel	1300x,609y	Mosaic 11803x,116y
------------------------	------------	-----------------------

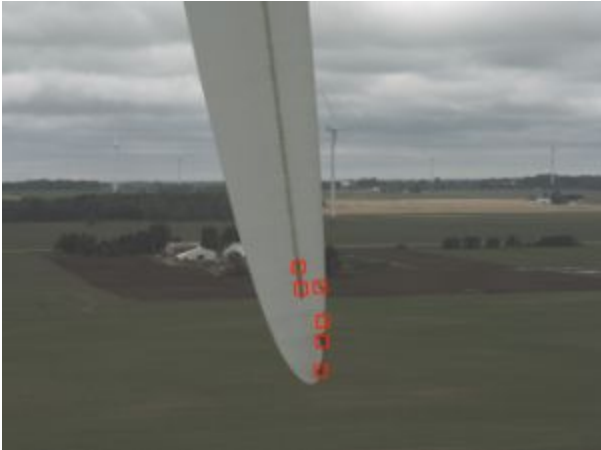
Original: DJI_0183.DNG (Larger Version)

MissingVortex Panel	1305x,1171y	Mosaic 12375x,84y
MissingVortex Panel	1315x,1267y	Mosaic 12407x,84y
GCE	1401x,1628y	Mosaic 12491x,76y
GCE	1409x,1498y	Mosaic 12459x,68y
GCE	1411x,1412y	Mosaic 12383x,52y
GCE	1399x,1259y	Mosaic 12315x,68y
