Wind Turbine Blade Inspection Report

Inspection Date: Jun 05, 2017

Client:
Site: Shroyer Wind Farm
Turbine: MW2 WTG-27

Turbine MW2 WTG-27

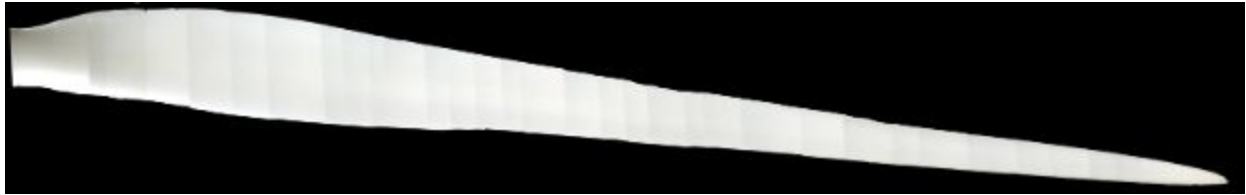
High Pressure

There were no damages identified on this side of the blade.

There are no feature images with EPRI Code >= 1 on this side of the blade.
